Laser Incident in the NASA Ames Unitary Plan Wind Tunnel

Wind Tunnel Operations Division
Ames Research Center, NASA

103rd Semi-Annual Meeting

May 2005
Buffalo, New York

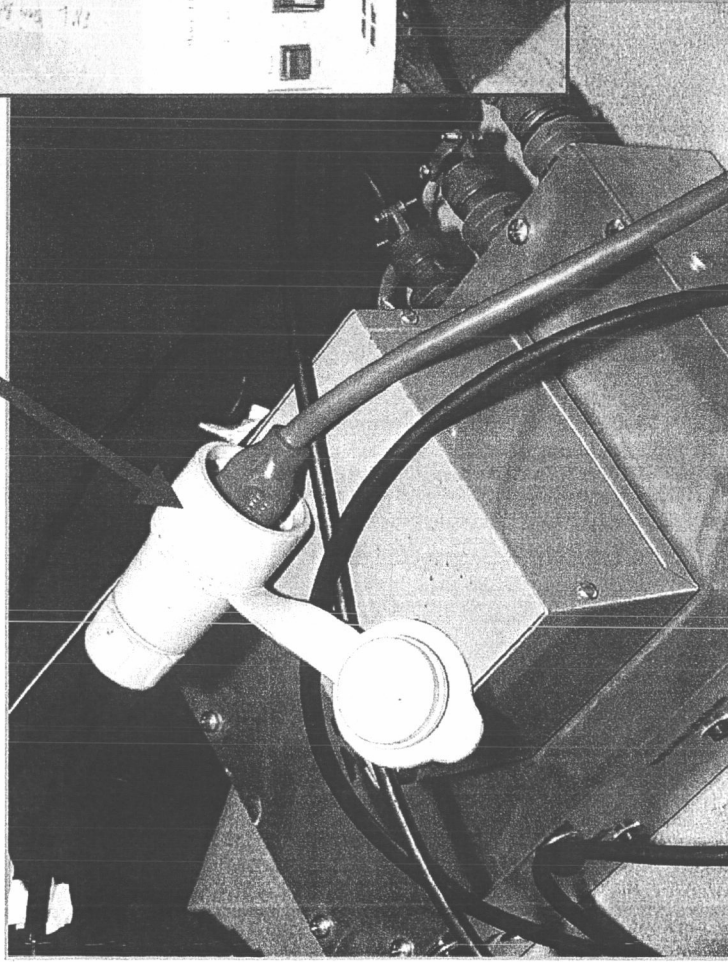
Safety Interlock Cable

Correct Connection - End of extension chord plugged into the interlock box.

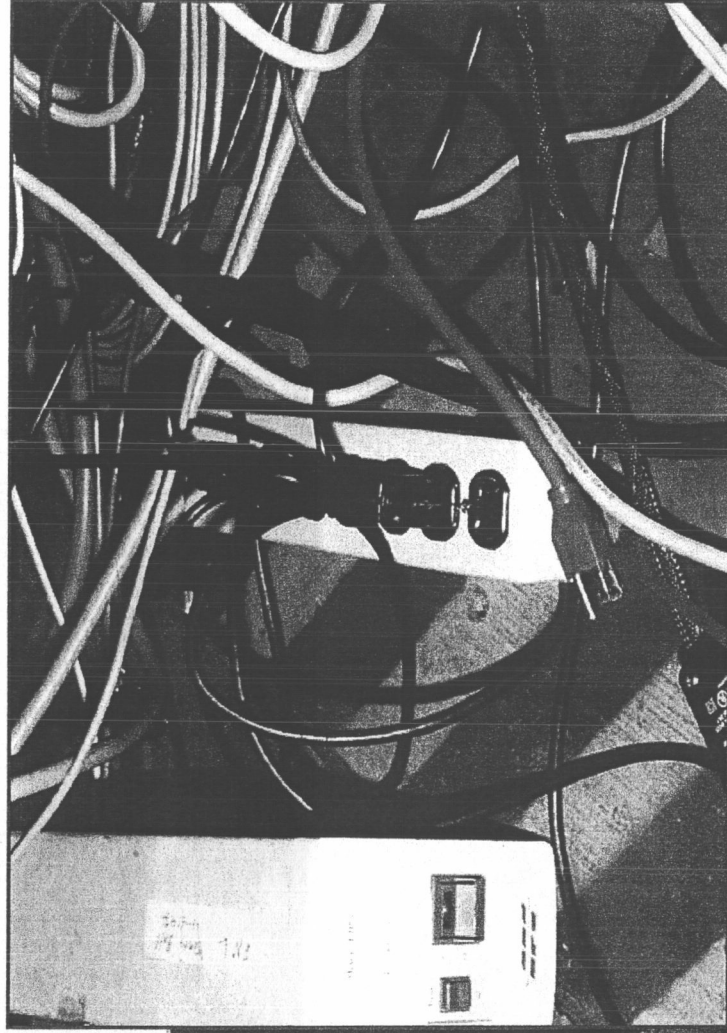
Incorrect Connection - End of extension chord plugged into outlet by mistake and therefore bypasses safety interlock system.

- Interlock switch bypassed
- Test personnel not in control of safety
- Inadequate physical barriers
- Schedule pressures
 - > 12 hour personnel shifts
- Rushed redeployment of laser system
- Change Request Review bypassed

- Modified interlock system with unique electrical connectors
- Lock Out Tag Out (LOTO) required for tunnel access when PIV system installed in facility.
 - Power supply locked out
- Physical beam block at laser head and window.
- Entire test team adopt 12 hour work rule
- Redefine what a configuration change is
- Installed emergency stop switches
